Delivery Order 9 Enhanced Preliminary Assessment

FORT BENJAMIN HARRISON, INDIANA

February 1992

USATHAMA DELIVERY ORDER 9
ENHANCED PRELIMINARY ASSESSMENT
FORT BENJAMIN HARRISON
INDIANA

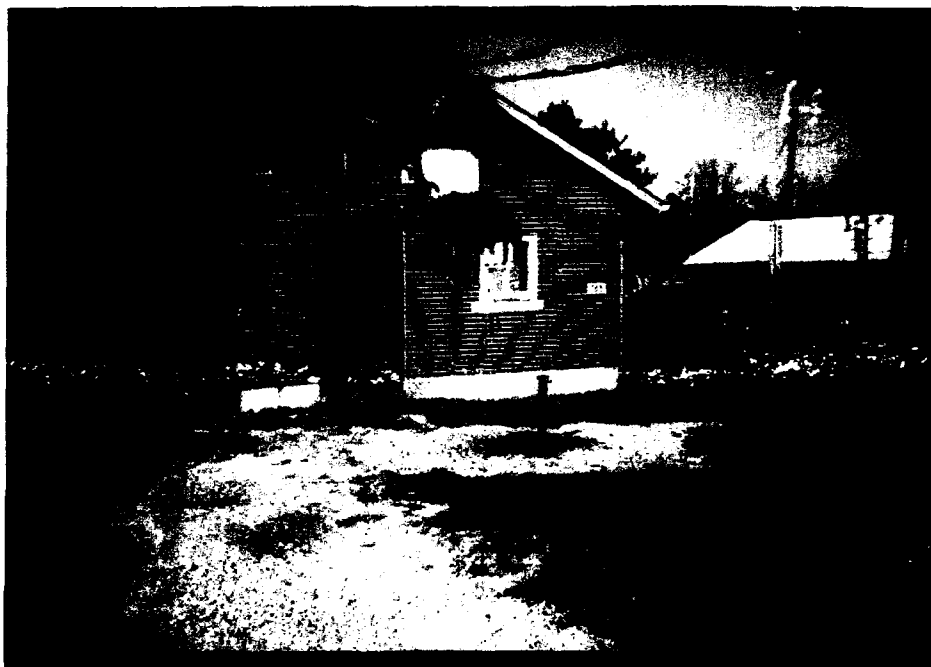
**7. STAINING AT WASTE OIL TANK, AUTO CRAFT SHOP
(BUILDING 705)**
